**Grady White 251 Coastal Explorer (CE)**

**GENERAL CONDITION, INSURANCE RISK  
AND VALUE SURVEY**

**February 15, 2024**

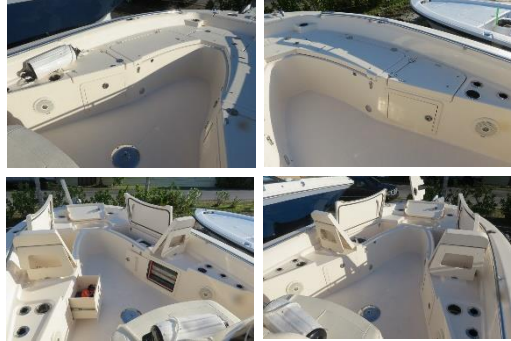
Molded fiberglass with sandwich core construction and gel coat finish. **[Harbor Blue]**

**Condition:** Sound where inspected; however, now needing cleaning, compounding, waxing, and buffing out.

# Topsides observed water stained; however, not severe. Have cleaned and waxed for new owner take over.
